**REPORT AND INVESTIGATION  
OF STRUCTURAL INTEGRITY  
ALL SAINTS ANGLICAN CHURCH  
FOXTRAP, NEWFOUNDLAND**

May 18th, 1993

Re: Report on Structural Integrity

All Saints Anglican Church, Foxtrap

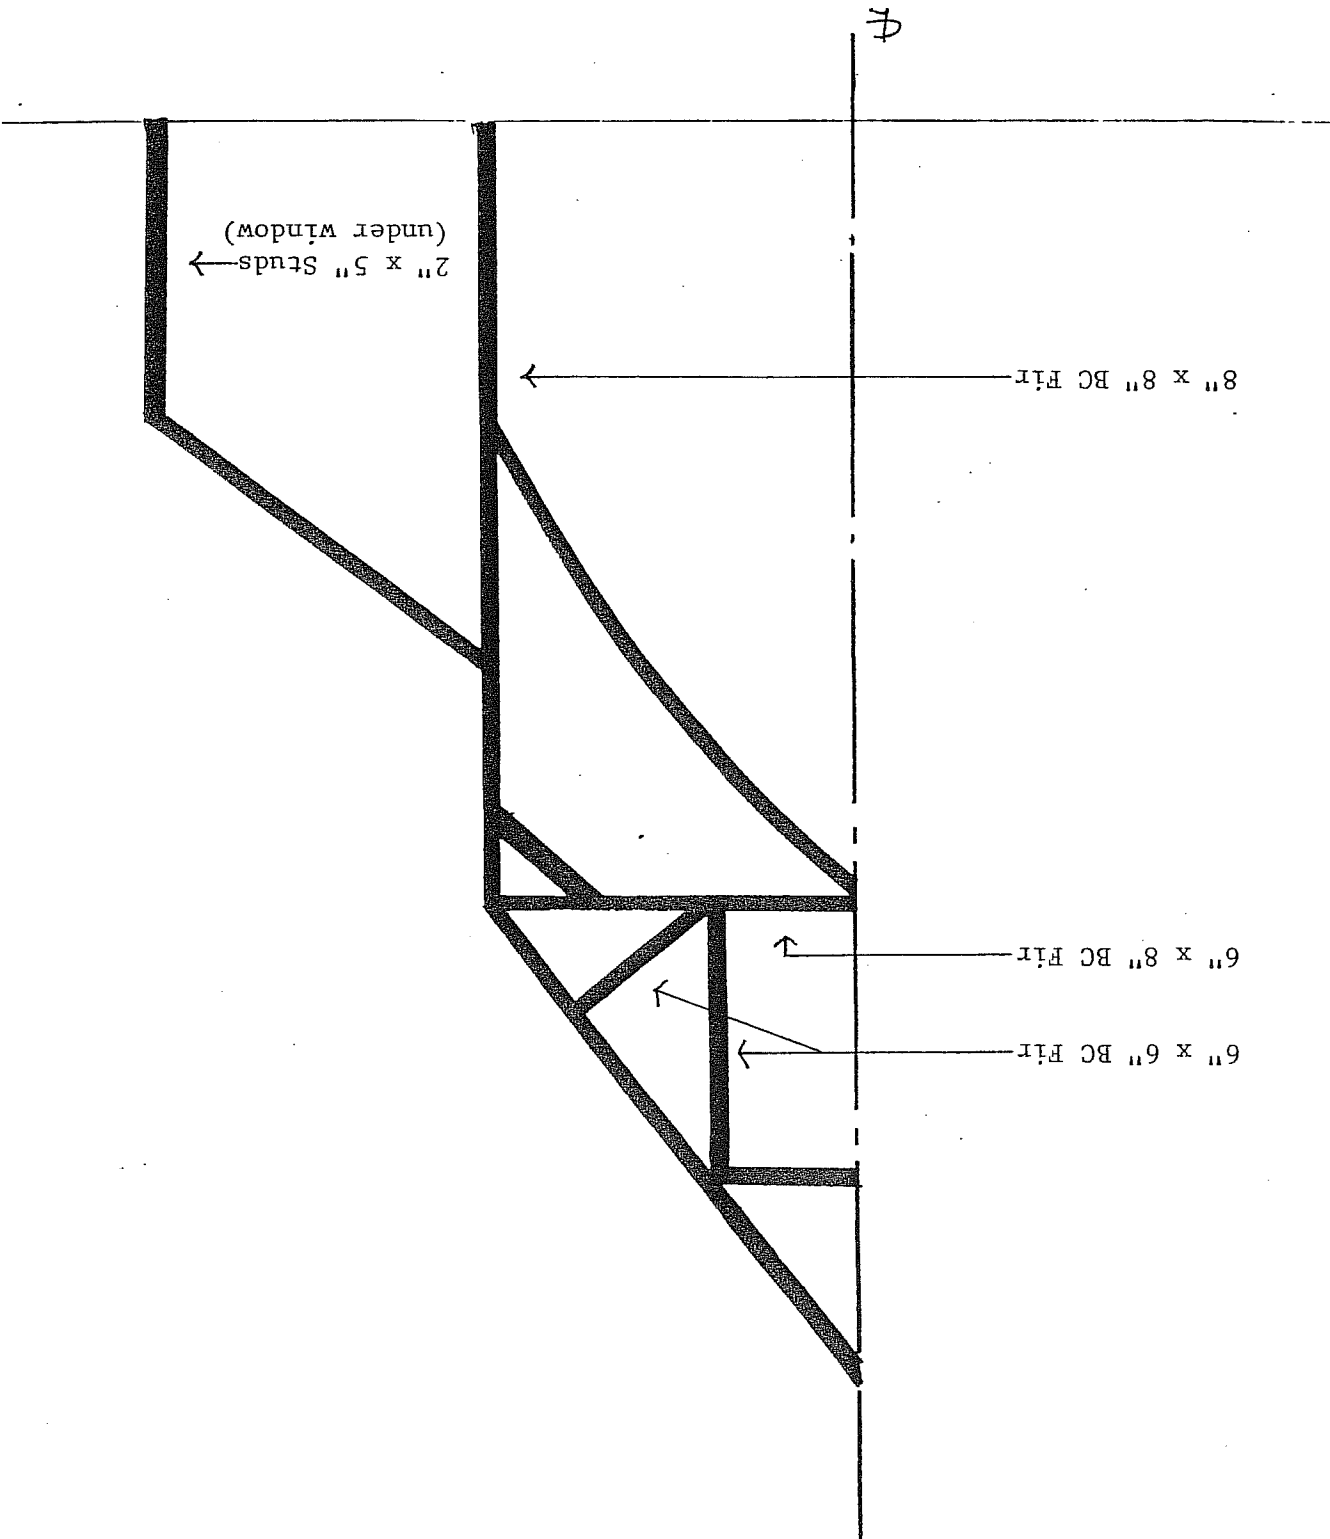
FIGURE 1

Figure 2 of Appendix B. The configuration as shown in Figure 1 of Appendix A is our best assumption of the structural arch and its components. This assumption is based upon site observations with limited structural exposure without reference to drawings which are not available.

As previously mentioned, the configuration of the arches as shown in Figure 1 is the existing arrangement of the structural elements that provide roof support and lateral stability. The configuration as shown is based upon the elements as seen above the finished ceiling and the elements as seen in areas where the interior finishes were removed.

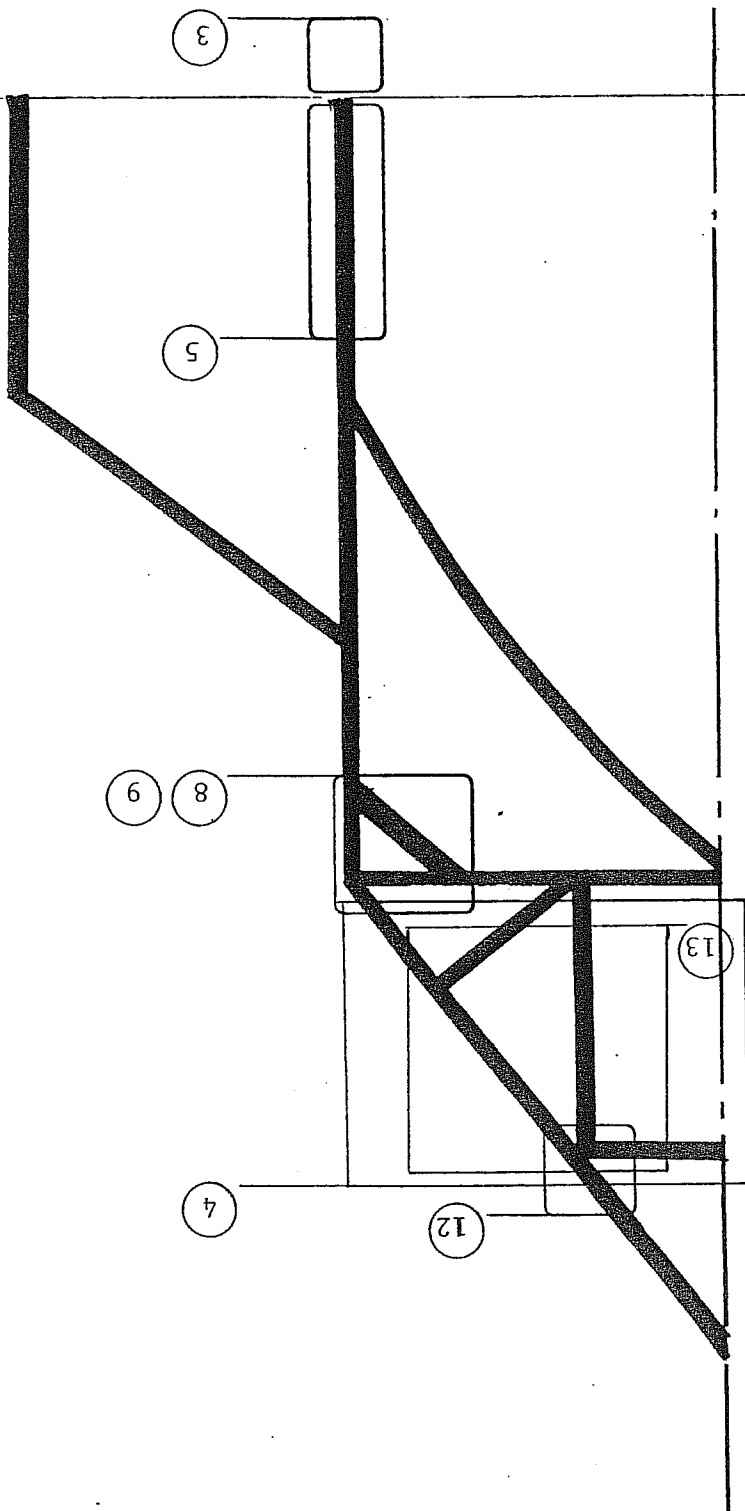
FIGURE 2

Additional photographs of the structure were taken above the ceiling. The location of each of these photographs is shown in

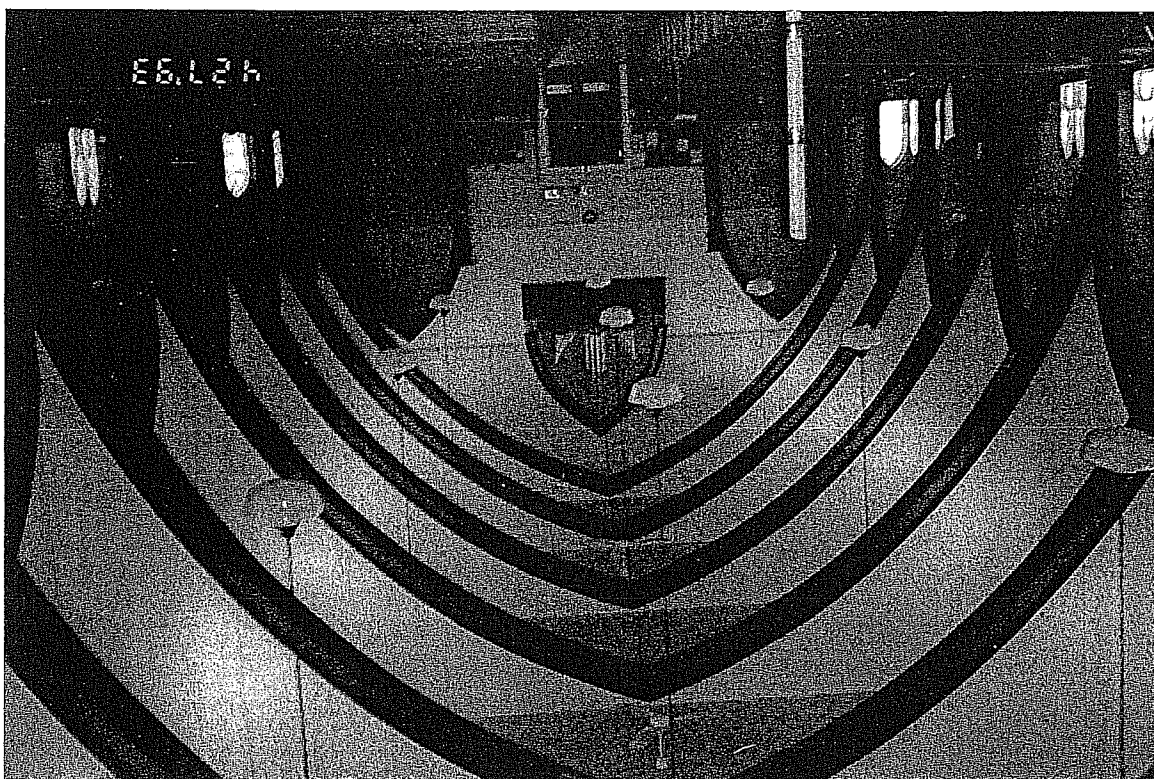
timber construction supported on concrete piers. A crawl space exists below the floor system. The structure supporting the roof consists of a series of wood arches (or trusses) which can be seen in Photo No. 2 of Appendix B. The columns for these arches are resting on concrete piers as can be seen in Photo No. 3 of Appendix B. The roof construction consists of timber purlins, wood sheathing and asphalt shingles. The roof construction can be seen in Photo No. 4 of Appendix B. The exterior perimeter walls are of wood construction having both aluminum and vinyl siding applied recently over the original wood clapboard.

Photo No. 2 - Church interior showing supporting arches

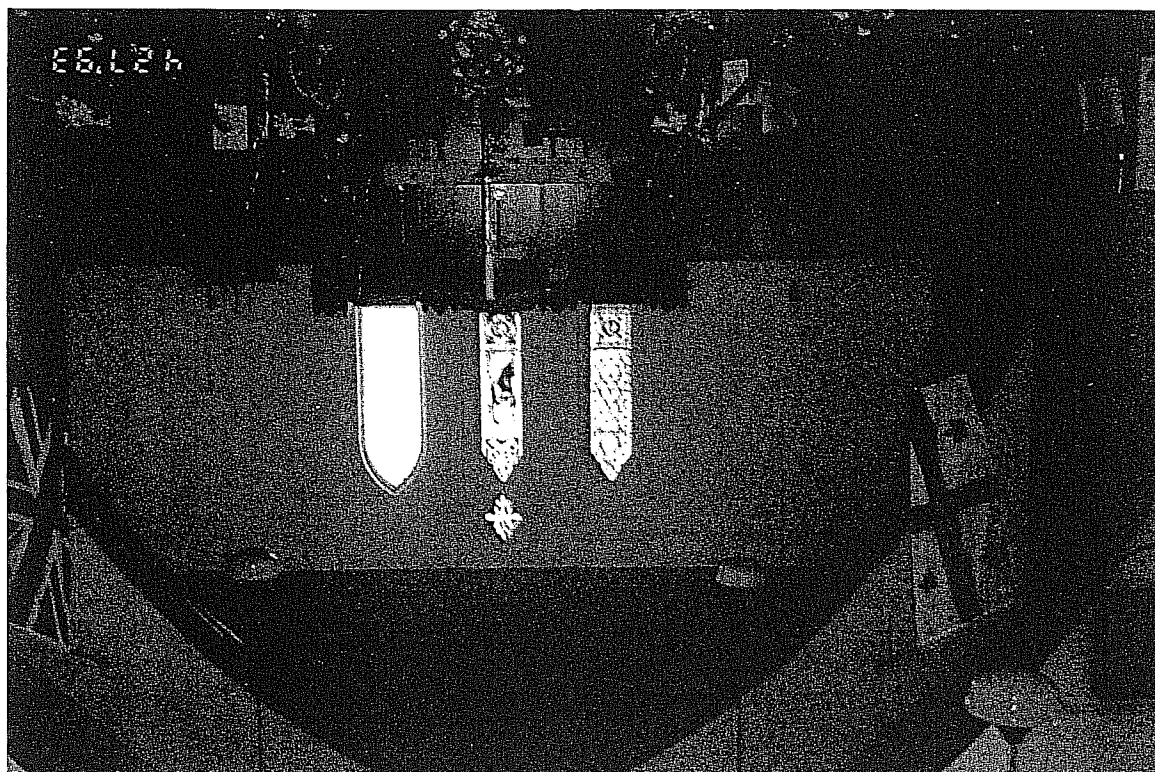
1. The east wall, shown in Photo No. 1 of Appendix B, moves considerably during high winds. On one occasion Rev. King cancelled the evening service because of his concern over the amount of deflection in the wall.

On another occasion the stain glass window in the east wall blew out (or in).

The east wall, which is reported to have excessive deflection, was not exposed. Its construction is probably wood studs and sheeting similar to other exposed areas. The wall does not have any projecting pilasters which one might expect to see if wind columns were utilized in the construction. Regardless of its construction, the wall is obviously inadequate to resist the wind loads imposed upon it since the reported deflections would exceed those permitted by today's building codes.

Photo No. 1 - East Wall

This wall should be strengthened by the introduction of wind columns or some method of bracing. In order to carry out this work, the interior finishes would have to be removed and most likely concrete footings would have to be constructed to accommodate the additional structural elements.

We also recommend that the east wall be braced as soon as possible regardless of which option is selected.

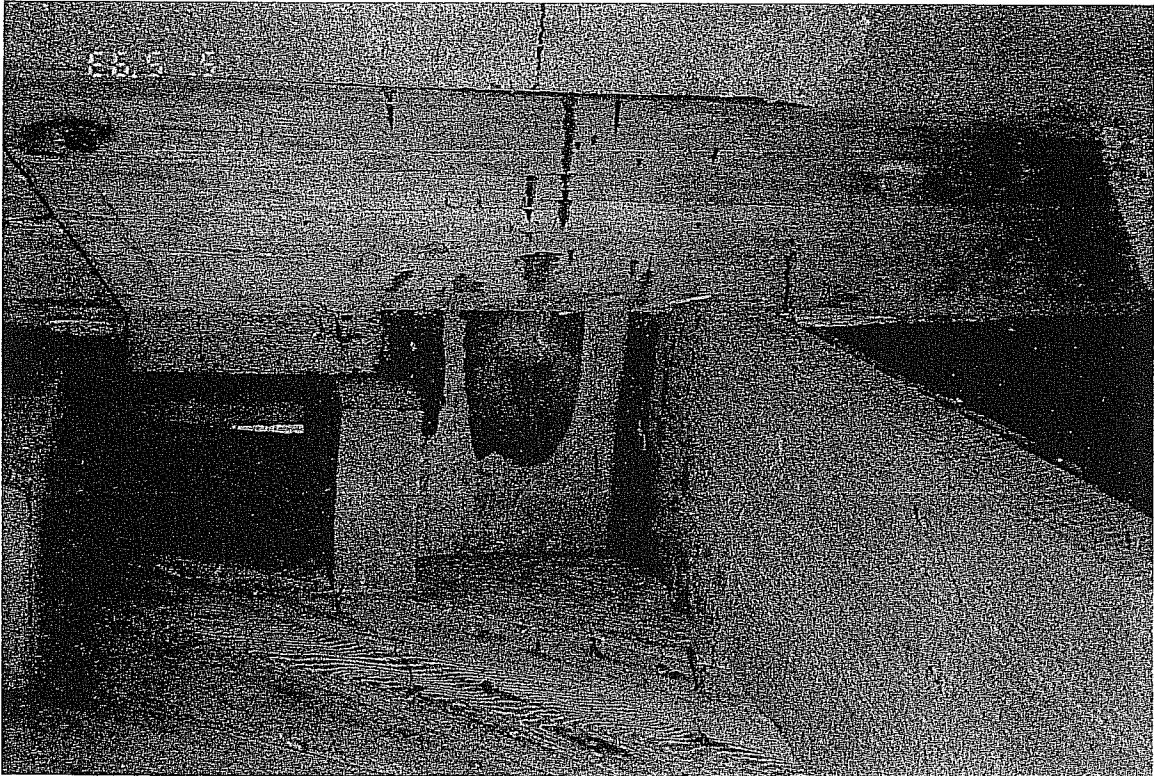
*Photo No. 3 - Column base supported on concrete piers*

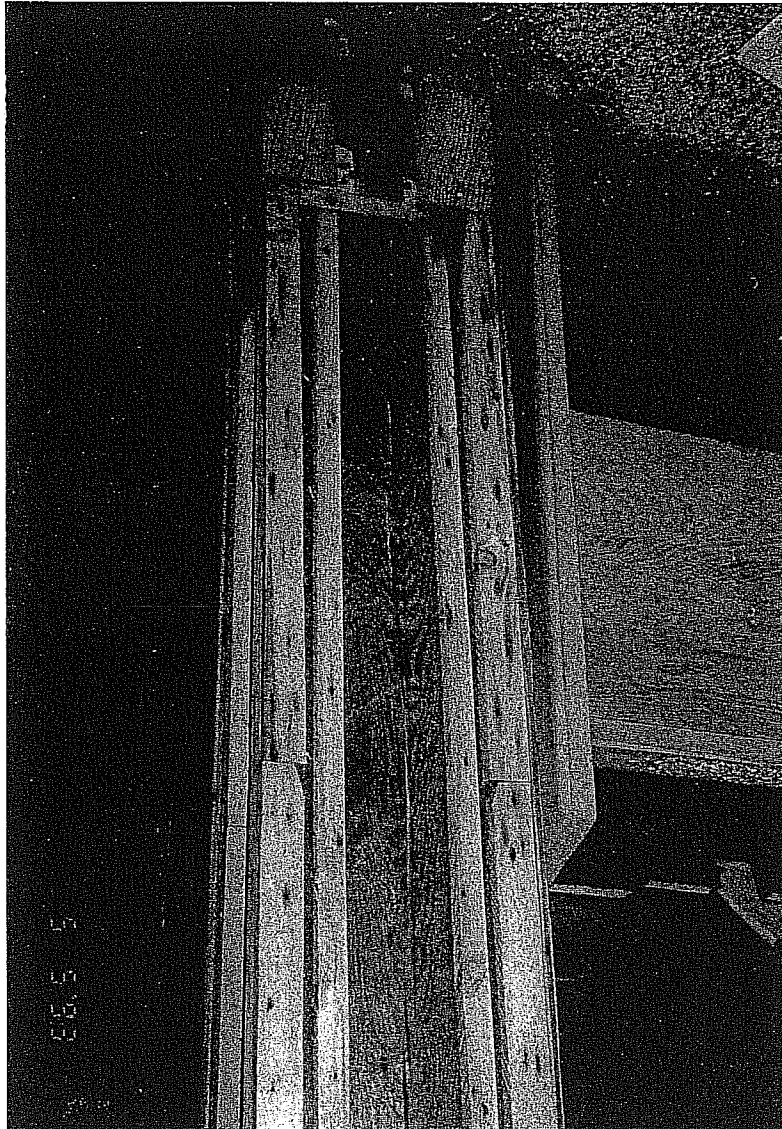
Two of the columns supporting the roof structure were exposed. See Photos No. 5 and 6 of Appendix B. The columns measured 8" x 8" and are of BC Fir. They were in good condition and did not show any sign of deterioration.

Photo No. 5 - Supporting column with interior finishes removed

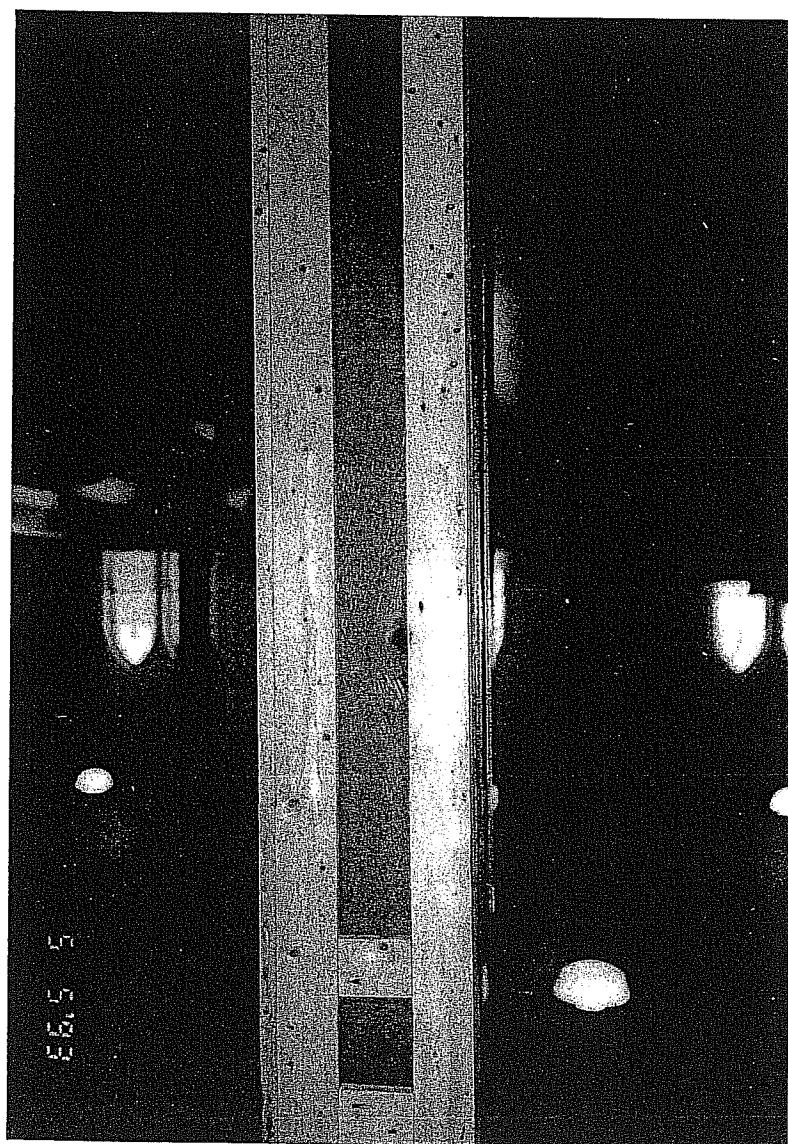
Photo No. 6 - Supporting column with interior finishes removed

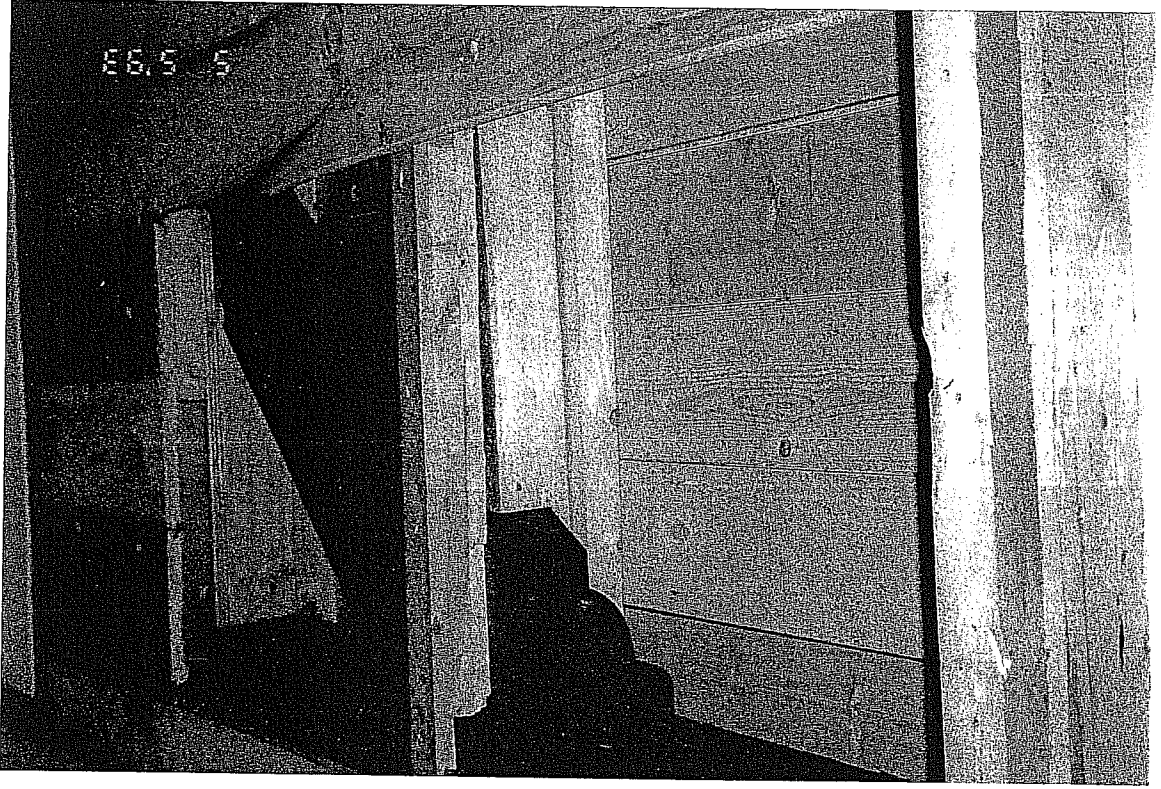
A section of sheeting was removed from the arch as shown in Photo No. 7 of Appendix B. The interior finish sheeting and the T & G sheeting, as can be seen in the photos, were added some time after the church was built - in more recent years. An inspection of the cavity between the T & G sheeting did not reveal any structural members above the arch other than a BC Fir knee brace which can be seen in Photo No. 8 of Appendix B. The knee brace was in good condition. A section of the T & G sheeting was observed to have a large split as can be seen in Photo No. 9. It is difficult to say whether the split was caused from building movement or drying out of the material.

Photo No. 7 - Interior arch with section  
of interior finish removed

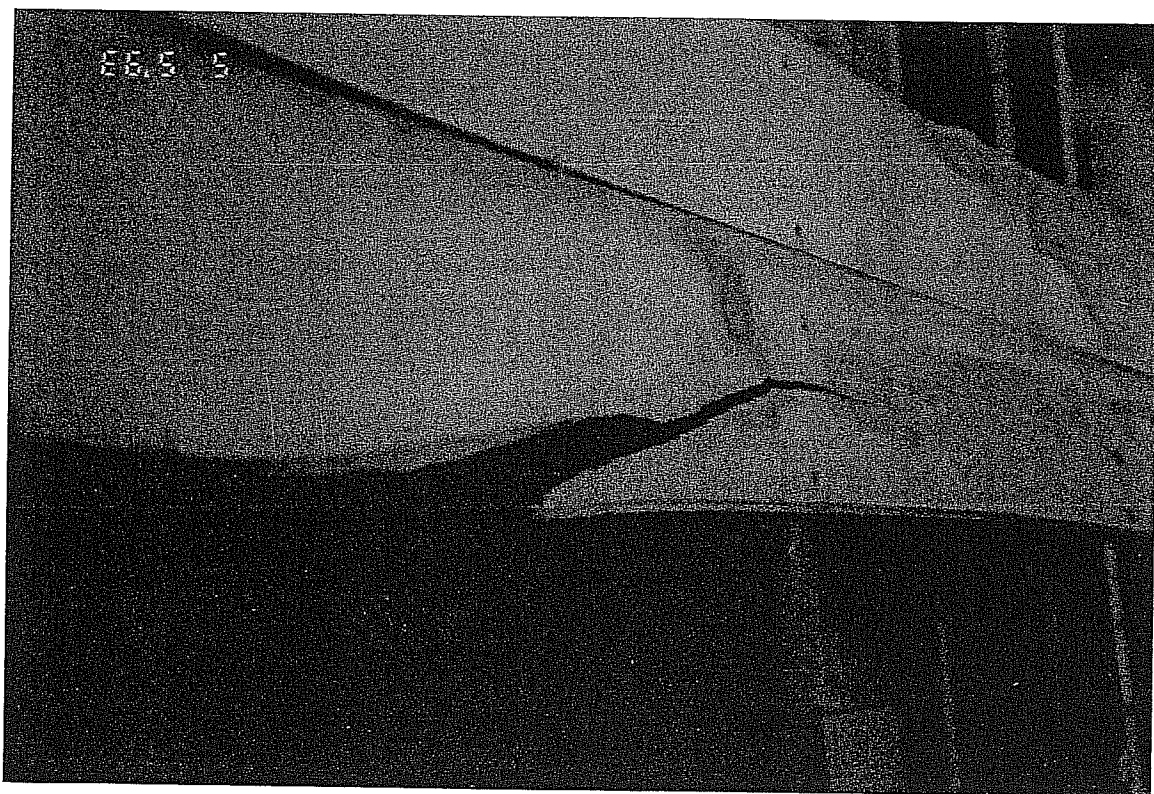
Photo No. 8 - Arch knee brace

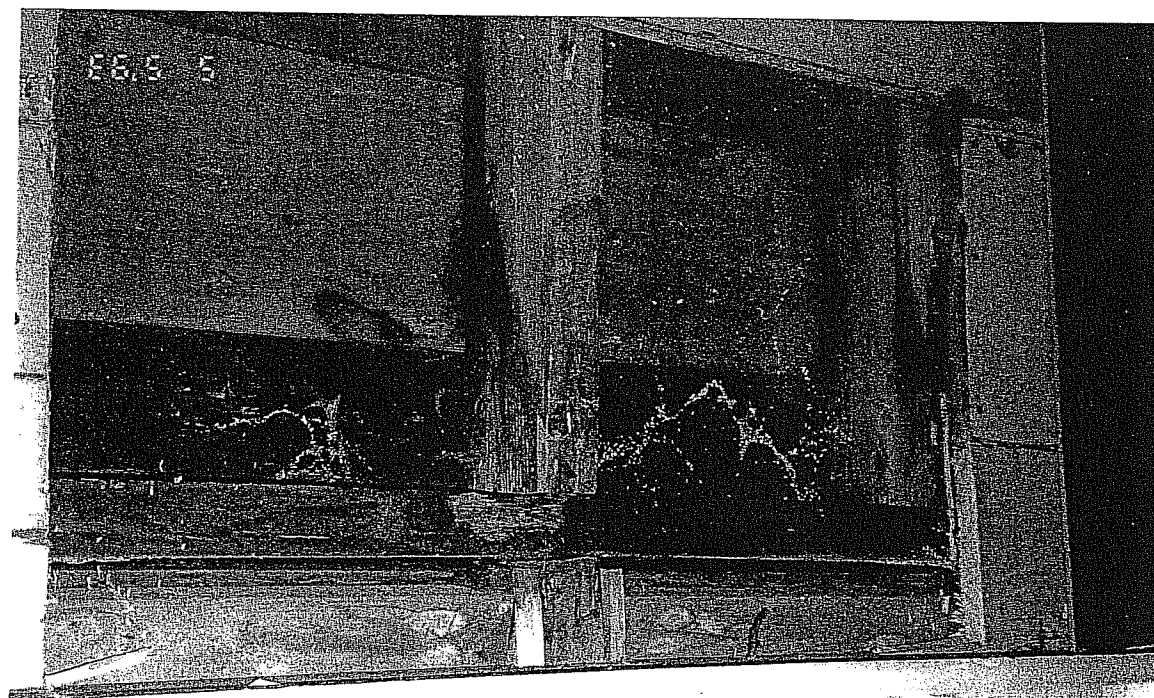
Photo No. 9 - Sheeting at knee brace -  
Note split in sheeting

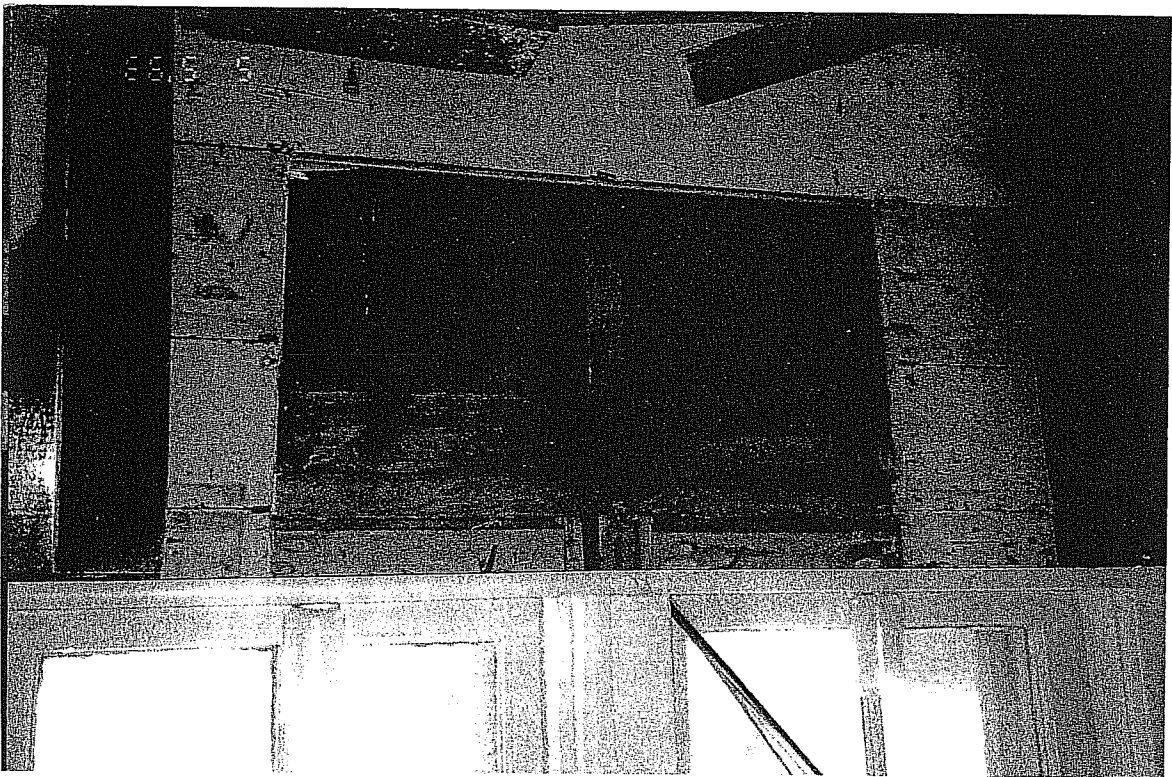
Interior paneling and sheeting was removed below two of the windows at the south side of the church. See Photos No. 10 and 11 of Appendix B. The studs are rough sawn 2" x 5". The studs showed signs of rot and deterioration, presumably from leaks around windows.

Photo No. 10 - Framing below windows, south side

However, it should be borne in mind that the church is 62 years old and the selection of Option 1 or 2 will still require maintenance and repair to windows and stud wall framing (of unknown extent). The selection of Option 1 would also require corrective action to be taken to resolve the leaking problems which currently exist. It should also be noted that the church is not energy-efficient in that the exterior walls are not insulated.

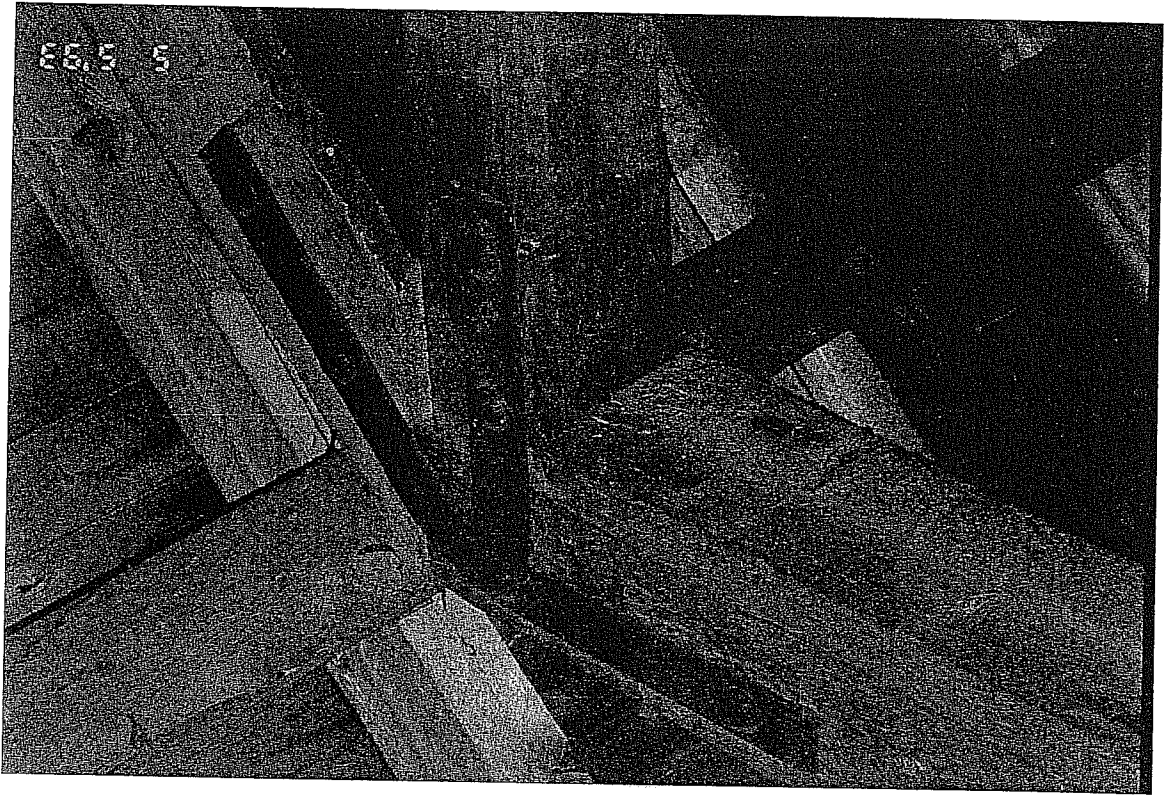
Photo No. 11 - Framing below window, south side

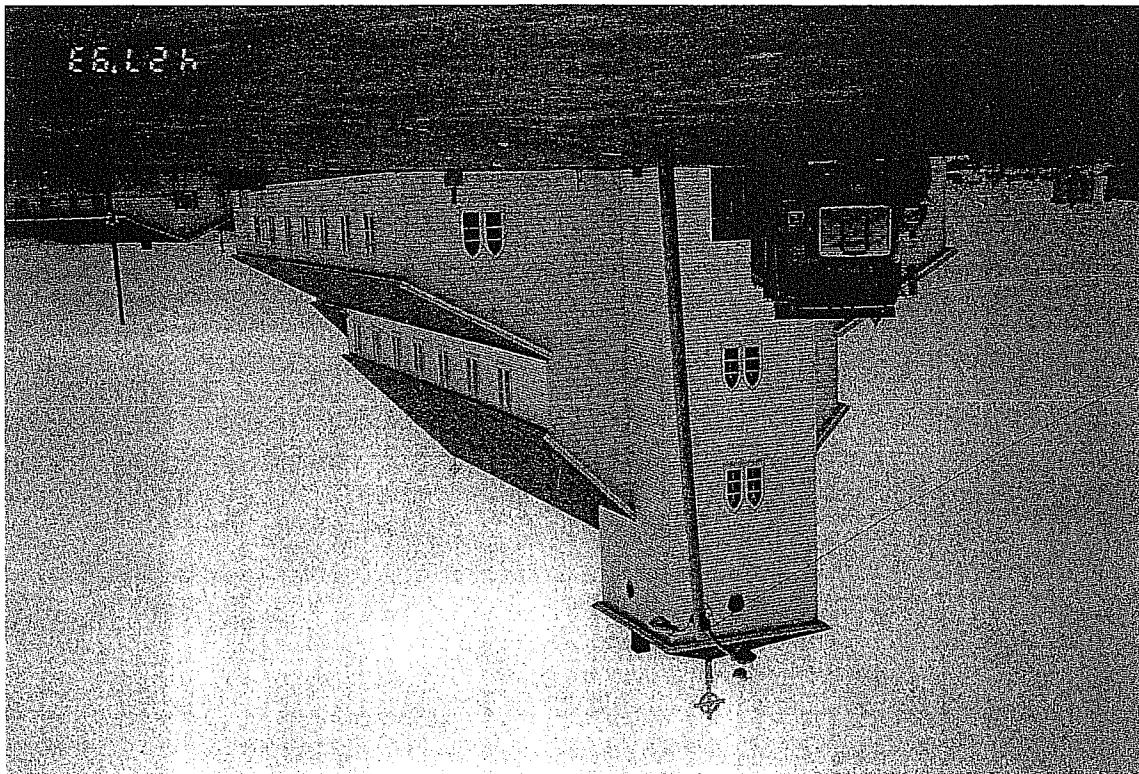
Photo No. 15 - Exterior view of west & south walls

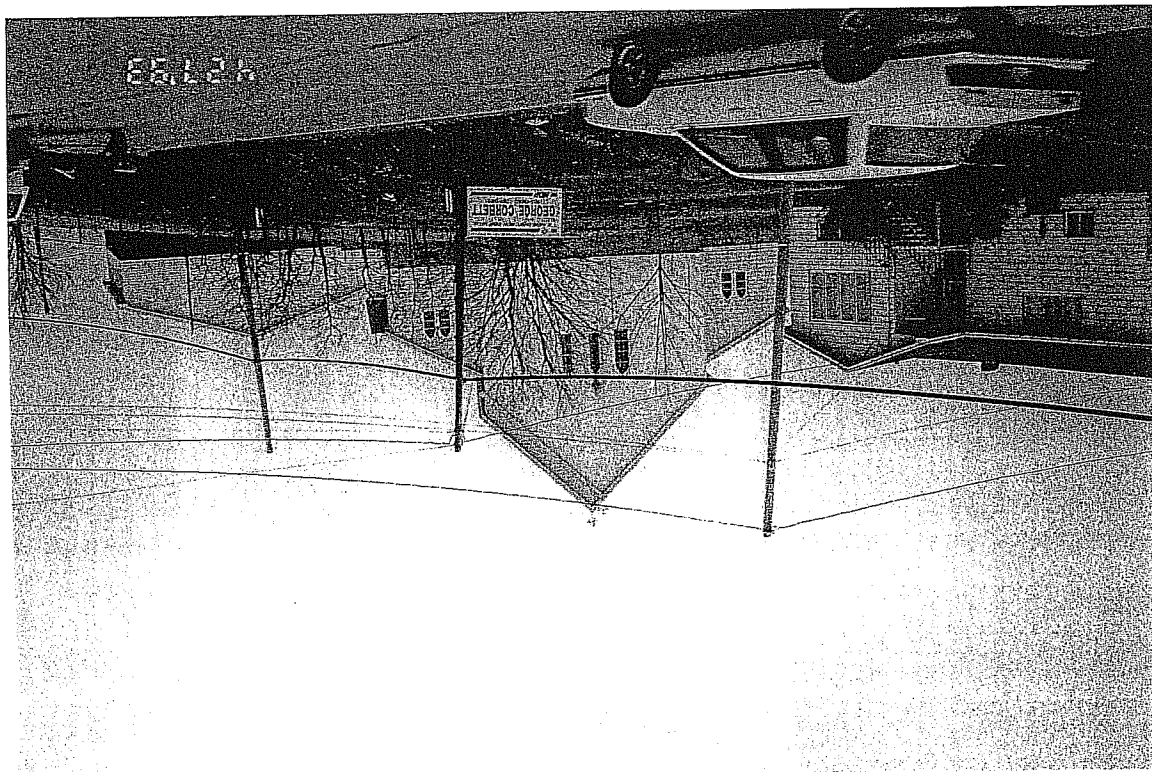
Photo No. 14 - Exterior view of east wall
