**REPORT AND INVESTIGATION  
OF STRUCTURAL INTEGRITY  
ALL SAINTS ANGLICAN CHURCH  
FOXTRAP, NEWFOUNDLAND**

May 18th, 1993

Re: Report on Structural Integrity

All Saints Anglican Church, Foxtrap

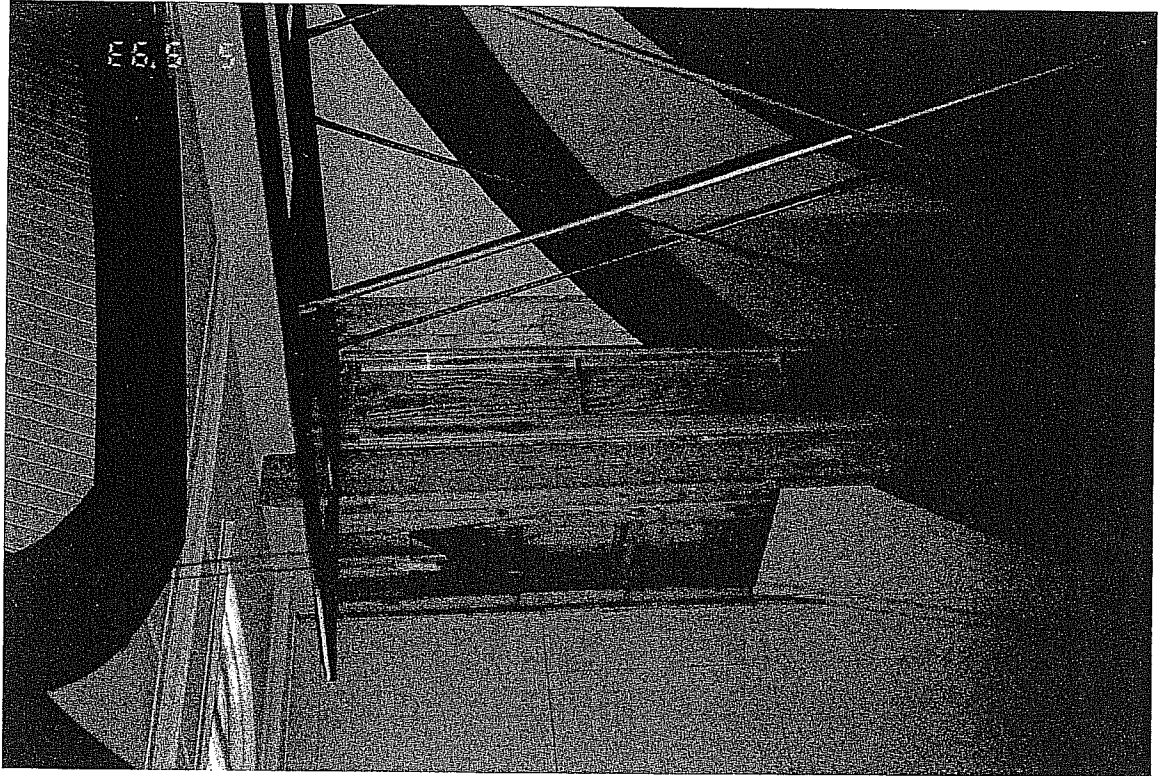
A section of sheeting was removed from the arch as shown in Photo No. 7 of Appendix B. The interior finish sheeting and the T & G sheeting, as can be seen in the photos, were added some time after the church was built - in more recent years. An inspection of the cavity between the T & G sheeting did not reveal any structural members above the arch other than a BC Fir knee brace which can be seen in Photo No. 8 of Appendix B. The knee brace was in good condition. A section of the T & G sheeting was observed to have a large split as can be seen in Photo No. 9. It is difficult to say whether the split was caused from building movement or drying out of the material.

Photo No. 7 - Interior arch with section  
of interior finish removed
